## **L'Escorxador**

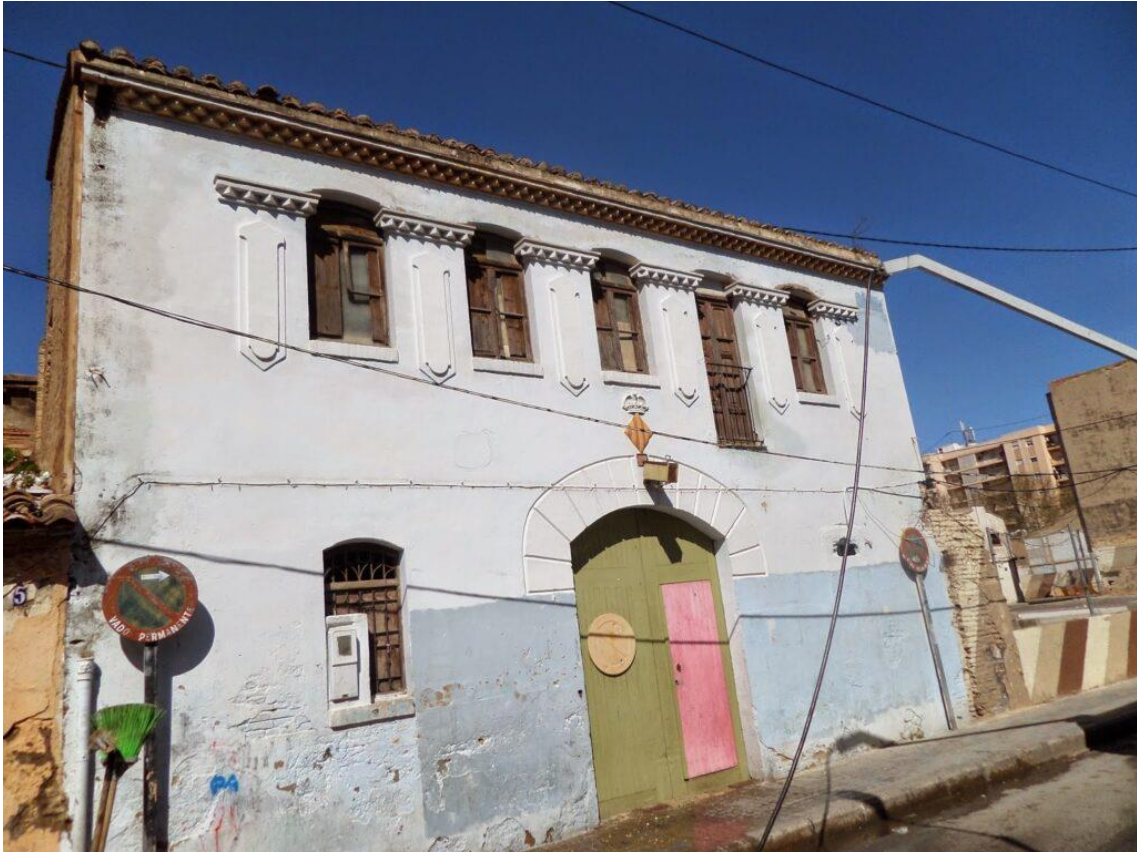
L'Escorxador, before the intervention. Photography: Els colors de la terra. Source: [https://tempsarts.cat/arts/wp-content/uploads/2021/11/escorxador-original-els-colors-de-la-terrajpeg-el\\_temps\\_de\\_les\\_arts-1024x768.jpg](https://tempsarts.cat/arts/wp-content/uploads/2021/11/escorxador-original-els-colors-de-la-terrajpeg-el_temps_de_les_arts-1024x768.jpg)

The facade is entered, on the first floor, by means of an access gate with a curved lintel that marks the central axis of the building; this is highlighted with a mock masonry cutout crowned by a coat of arms in relief of the city of Valencia; on both sides there are two symmetrical openings, of which only one is preserved.

Upstairs there are four identical windows and a balcony door with parapet, probably from a later intervention. Decorating the panel are geometric pieces in projections crowned by molding. The building is topped by an eave over a dentil cornice.

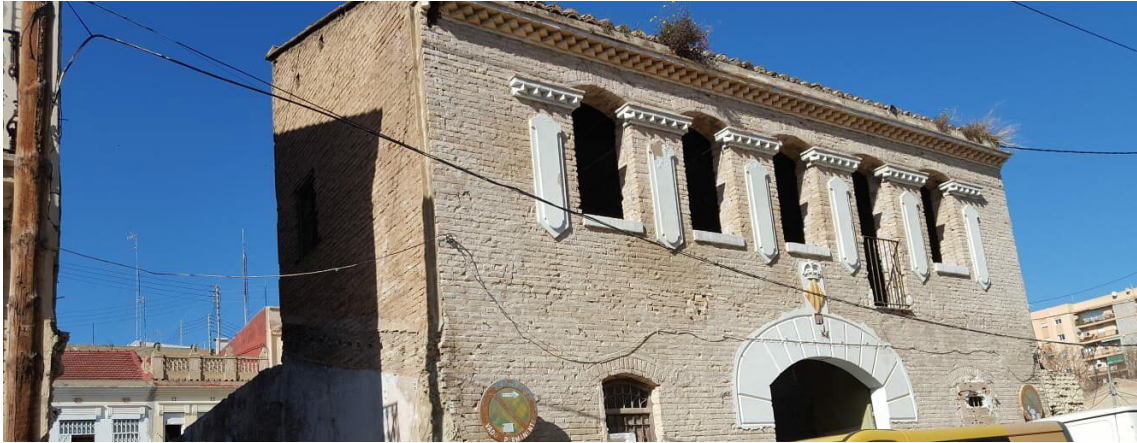
Another image of the building before the rehabilitation. Source: <https://www.flickr.com/photos/ajuntamentdeValenciaprensa/32083253367/in/photostream/>
